IN THE PROVINCIAL COURT OF NEWFOUNDLAND

*A Judicial Inquiry into the Causes and Circumstances surrounding an explosion and fire at the **Come By Chance Refinery**, Come By Chance, Newfoundland and Labrador, occurring on March 25, 1998 which caused the deaths of Jerome Kieley and James Mercer.*

DATE OF REPORT: *August 8, 2005*

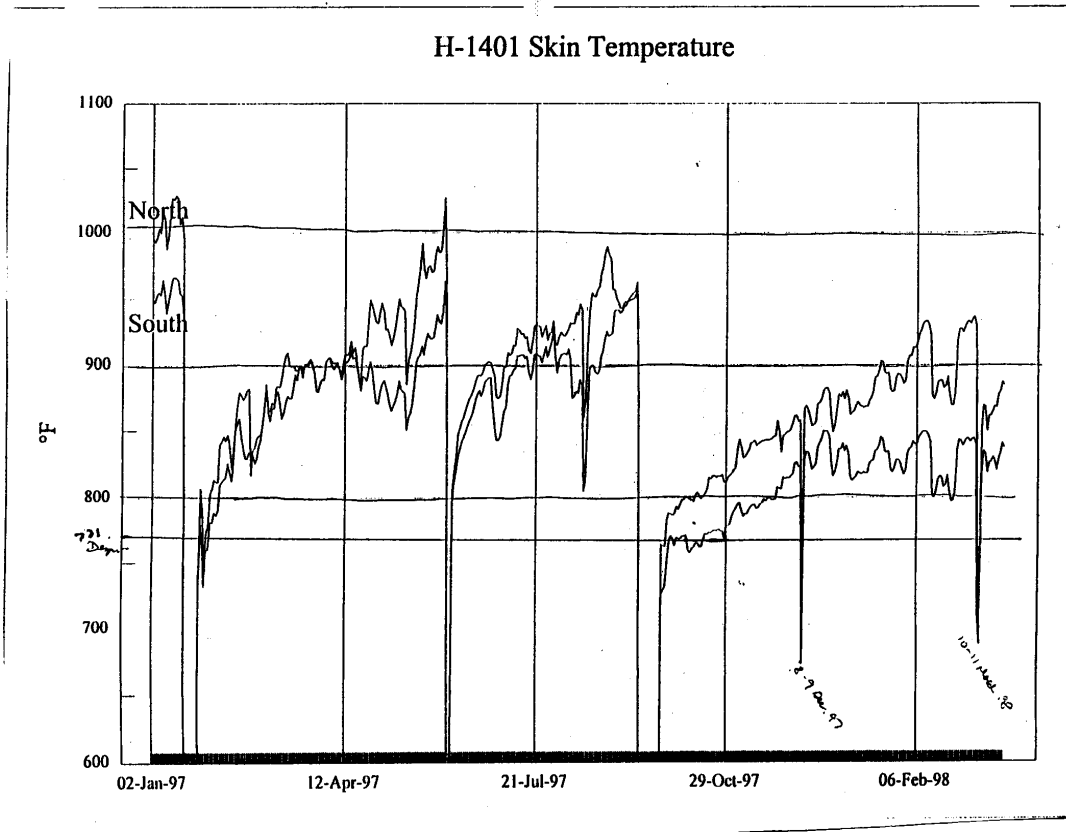
OHS 3 TAB. 9

September 1997. Thereafter, the skin temperatures again rose to approximately 950° just before the middle of March 1998.

From January 1, 1997 until March 25, 1998, the tubes on the north radiant wall consistently had a higher skin tube temperature than those on the south radiant wall of heater 1401.
